| SECURITY CLASSIFICATION OF THIS PAGE (When Data Entered) | | REPORT DOCUMENTATION PAGE | READ INSTRUCTIONS<br>BEFORE COMPLETING FORM |
|---|---|--|---|
| THE EVALUATION OF A PROPOSAL FOR INCORPORATING AN ECP ON AN OH-58A LIGHT OBSERVATION HELICOPTER | | Student Project Report, 74-1 | |

**STUDY TITLE:** The Evaluation of a Proposal for Incorporating an ECP on an OH-58A Light Observation Helicopter.

STUDY REPORT  
PMC 74-1

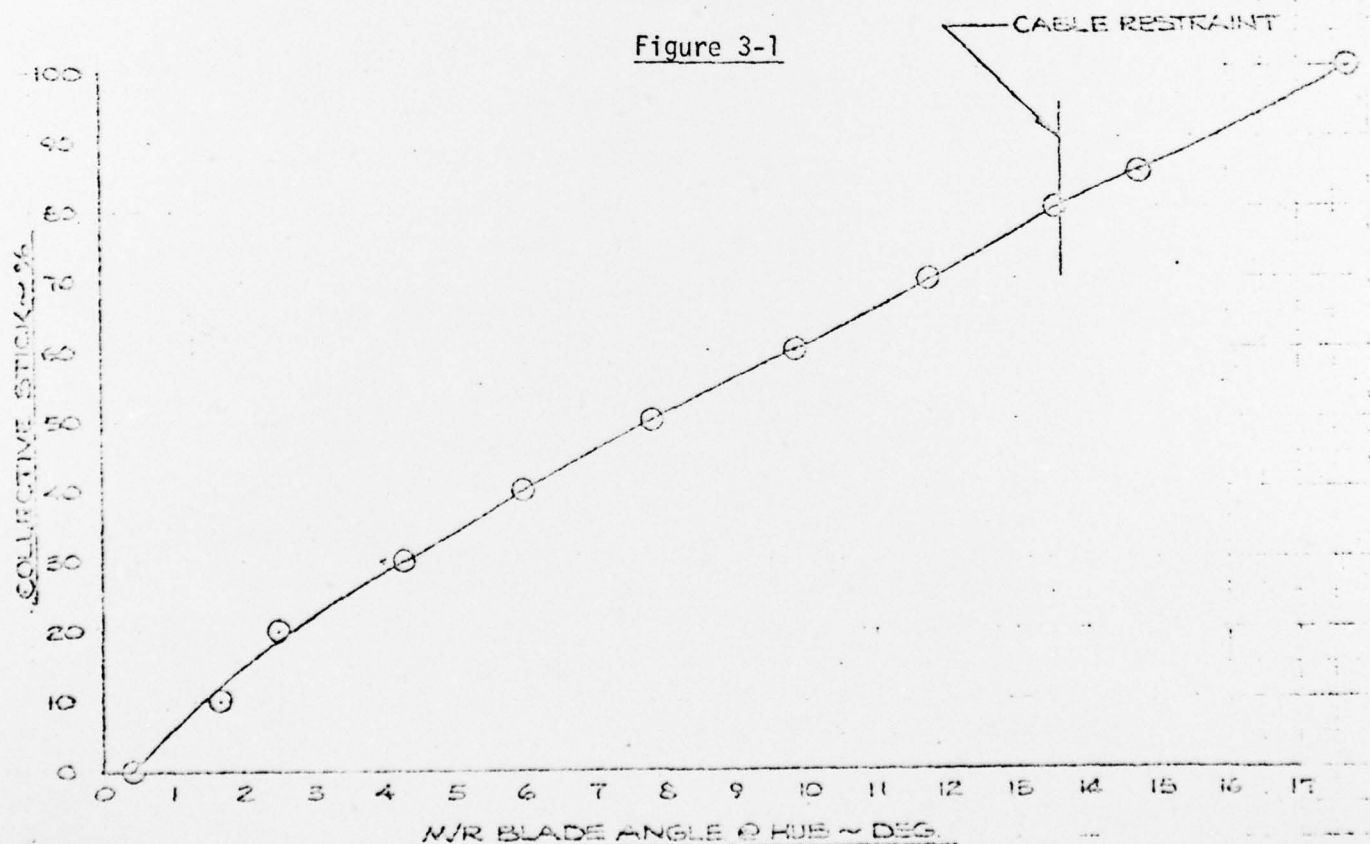
At the request of the PM, the manufacturer's approach to eliminating the tail-boom resonance problem was presented as an Engineering Change Proposal (ECP, OH-58A-140) for consideration. With the concurrence of the PM, BHC designed, fabricated, and installed the hardware proposed in the ECP on an OH-58A that had been bailed to the contractor. This hardware was a simple cable device installed in the control system such that the collective control travel was limited to 80 percent of the original total design travel. Figure 3-1 shows a plot of main rotor blade pitch angle versus collective control position.

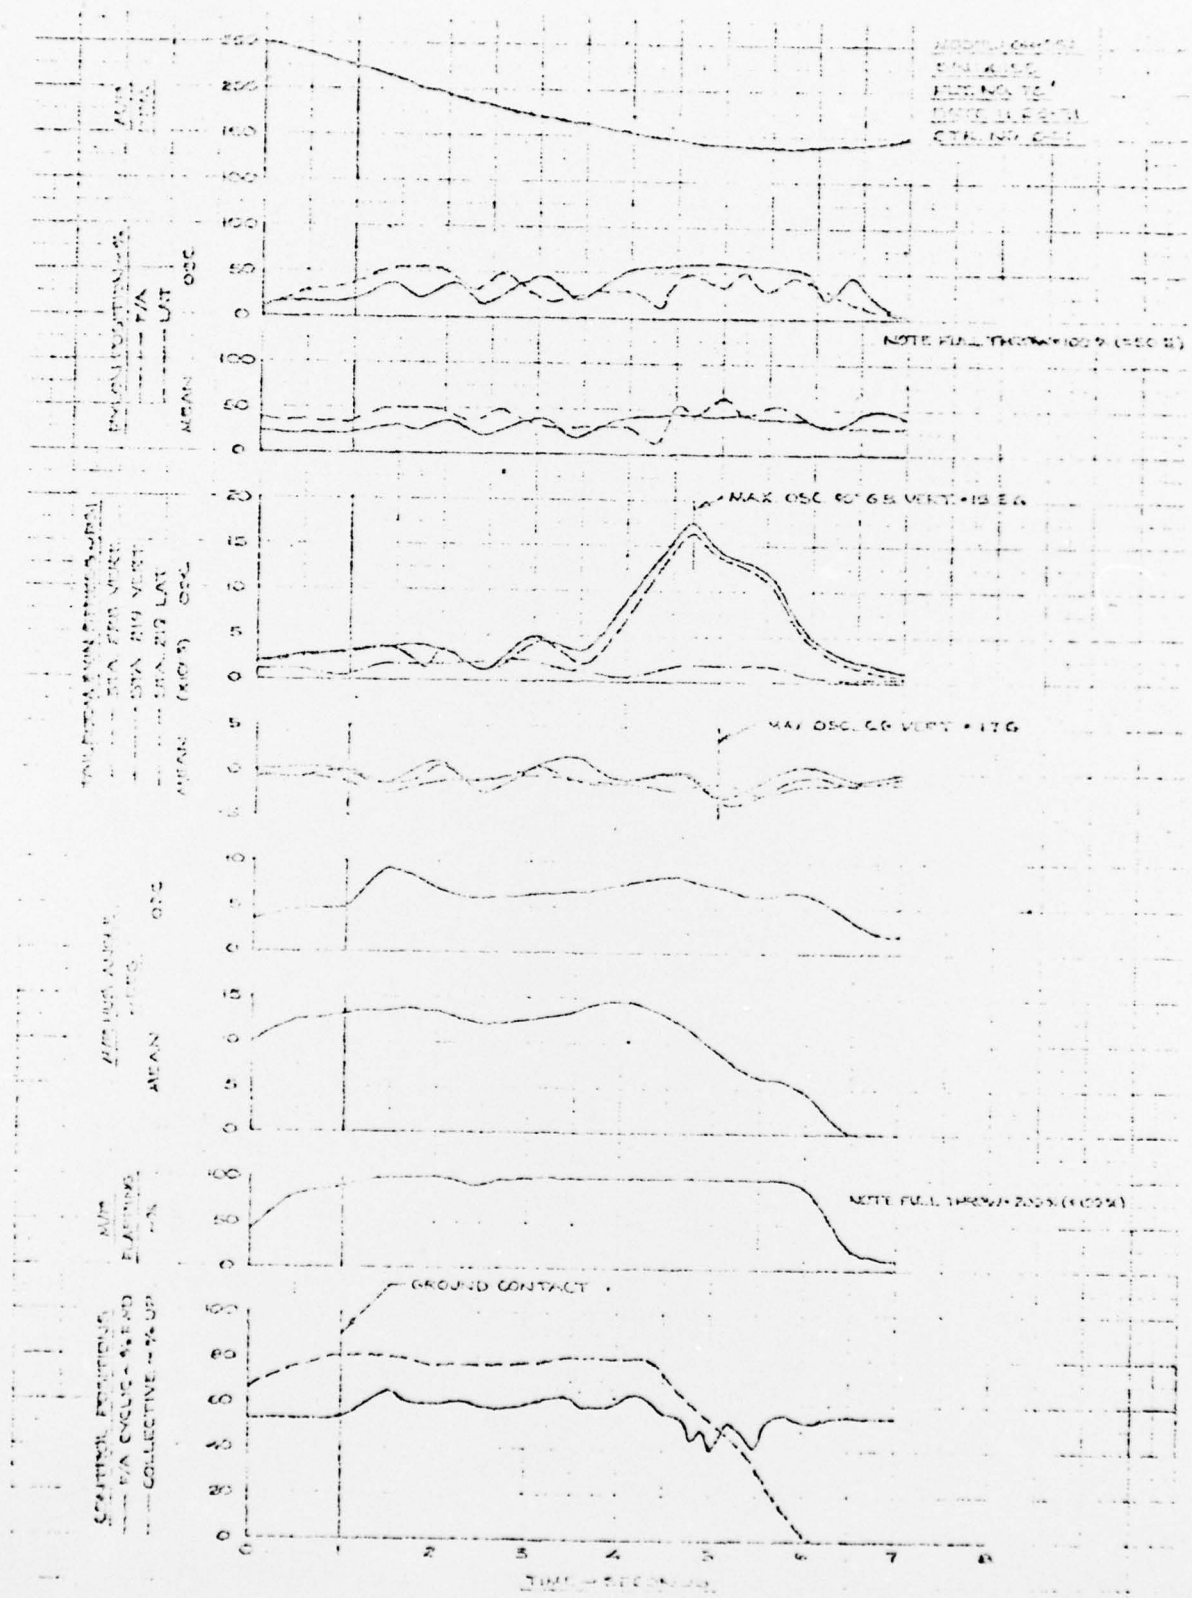
Presented in Figure 3-3 is a typical time history of an autorotative landing whereby tail-boom resonance was encountered. As may be seen in this figure, all of the available collective control was applied approximately .20 seconds prior to actual touchdown. As also may be noted in this figure, main rotor flapping reached 100 percent approximately .35 seconds after touchdown. As previously stated, the touchdown airspeed during this maneuver was approximately 40 knots indicated, which is well in excess of that used operationally. Shown in this figure, no pilot control inputs contributed to the excitation of tail-boom resonance.

incorporation of the collective control restriction device did not preclude the excitation of tail-boom resonance. Incorporating the collective control restriction device did, however, extend the airspeed at which the onset of tail-boom resonance occurs beyond the airspeed utilized for touchdown during normal operations. Results of tests conducted at the high altitude test site (9,500 feet) revealed that a degradation in autorotative performance of the OH-58A is experienced with incorporation of the collective control restriction device.
